## **Limited Visual Dam Safety Inspection Summary Report**

**HI - 00040**

**Waikoloa 50 MG Reservoir 1**

**May 2006**

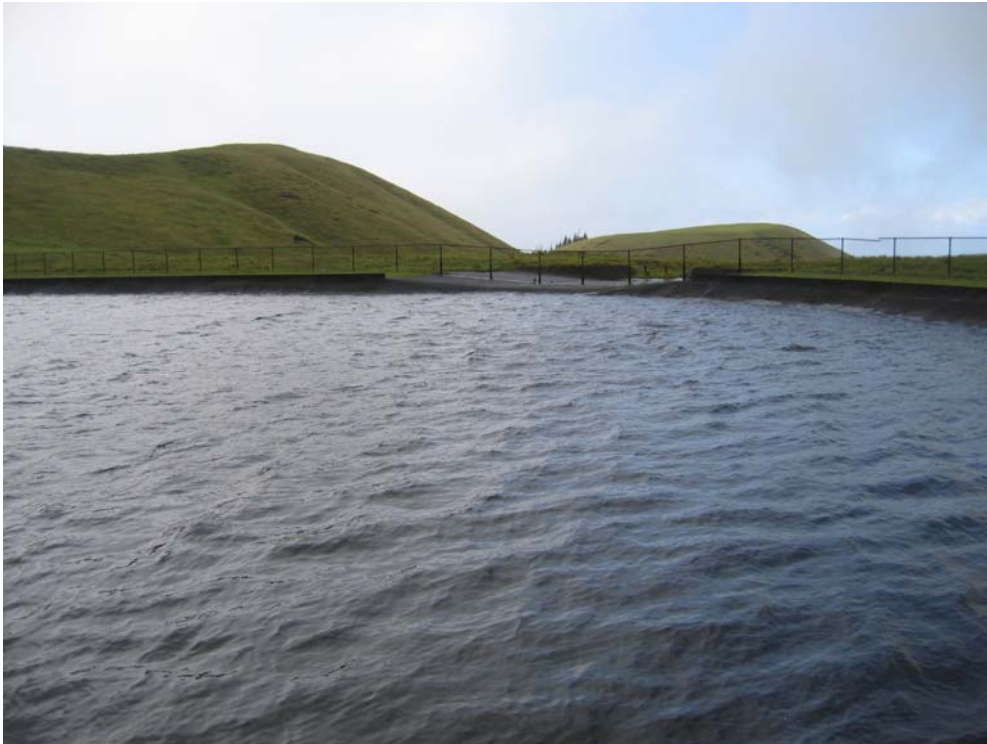
This spillway consisted of an ungated, concrete lined channel.  
The rough dimensions were 45 ft length by 60 ft width at the dam centerline.  
The spillway channel runs perpendicularly from the dam and is unlined.  
The invert elevation is 3332.9 ft.  
The spillway approach was clear.  
There was no erosion observed near the spillway.  
The downstream vegetation appears to be primarily low ground cover.

- a. The Spillway appeared to be in satisfactory condition, no corrective actions are required at this time.

**Photo 1 Spillway looking downstream.**

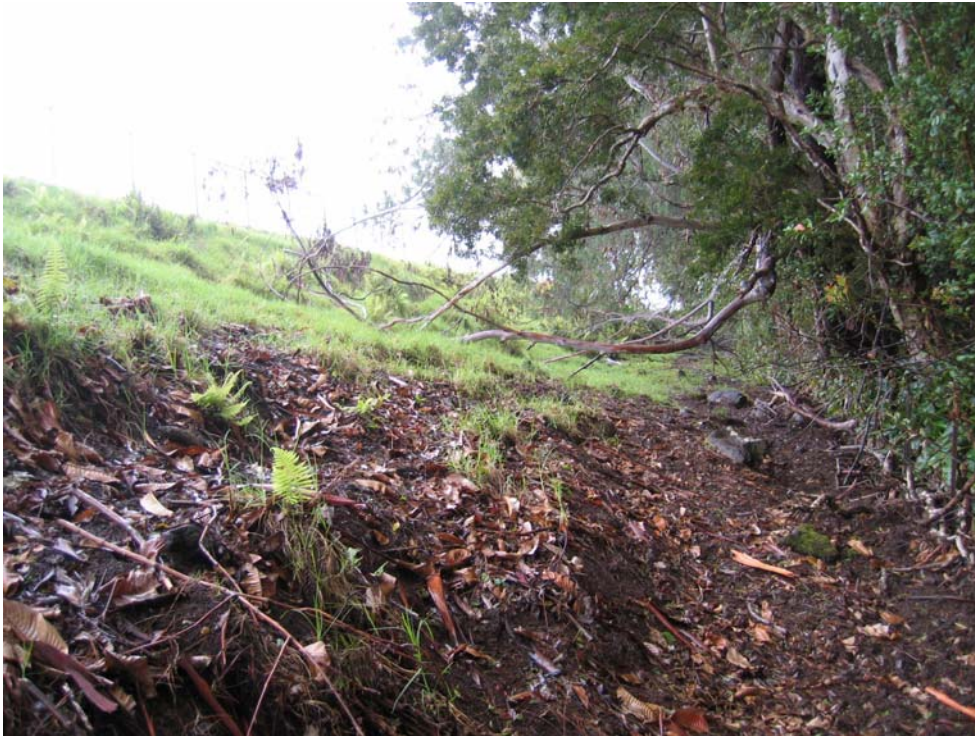
Small gully erosion was observed on the downstream slope, on the north side; the gully was 12 inches wide and 6-12 inches deep. Sinkholes were not observed on the downstream slope. Vegetation was observed on the downstream slope. The majority of the vegetation was low ground cover, with 23 woody trees less than 6 inches diameter. Seepage was not observed on the downstream toe.

- a. The downstream slope appeared to be in fair to poor condition and requires corrective action.
- b. Rut and/or Gully erosion was observed on the slope, which requires maintenance and/or repair. Description: described above
- c. Tree(s) were observed on the downstream slope. Trees have been identified as the probably cause of piping failures, and can possibly cause severe damage to the embankment if they are uprooted during a high winds. Corrective action is required to remove the tree hazards from the dam. Acceptable remedies include removal of the tree and its root structure down to a 2" diameter and reconstructing the damaged embankment section. All repair work shall be accomplished as per the requirements of licensed geotechnical or structural engineer. Routinely monitor the damaged area for signs of settlement and seepage.

**Photo 2 North side downstream slope.**

- ☐ e. Slope protection needs maintenance or repair. Description: \_\_\_\_\_
- ☒ f. Rut and/or Gully erosion was observed on the slope, which requires maintenance and/or repair.  
Description: fill compact, regrade gully

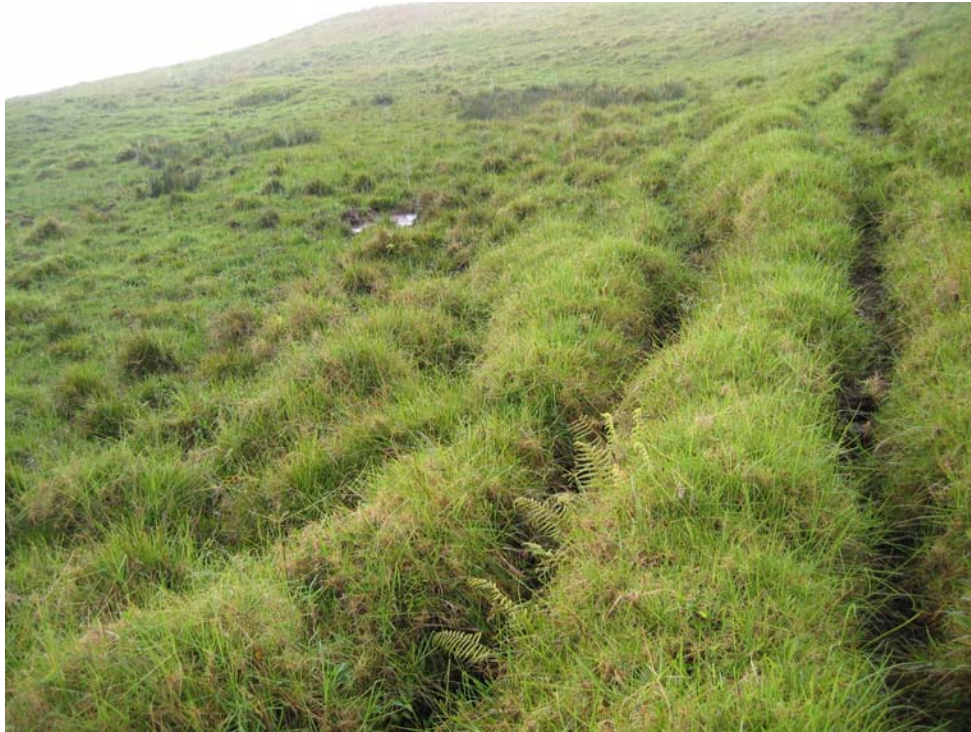
Erosion along the abutment or toe was not observed. Two areas were noted along the toe that could be possible seepage spots. These locations were observed: (1) near the east side of the reservoir, which could not be determined as to flow due to wet conditions; and (2) in the northern area, near inlet piping, as evidenced by iron staining. Green, lush vegetation indicated both potential seeps.

**Photo 3 Downstream toe seep area 1.**

Description: Seep on the east side of reservoir, could not identify if flowing due to wet conditions

- a. The abutments/toe appeared to be in fair to poor condition and requires corrective action.
- b. Seepage/Ponding water was observed. Monitor and conduct further investigation to locate the source of water and extent of any possible hazardous or developing condition.
- c. Clear debris from toe area on north side to ease inspection.

- ☒ j. Seepage/Ponding water was observed. Monitor and conduct further investigation to locate the source of water and extent of any possible hazardous or developing condition.

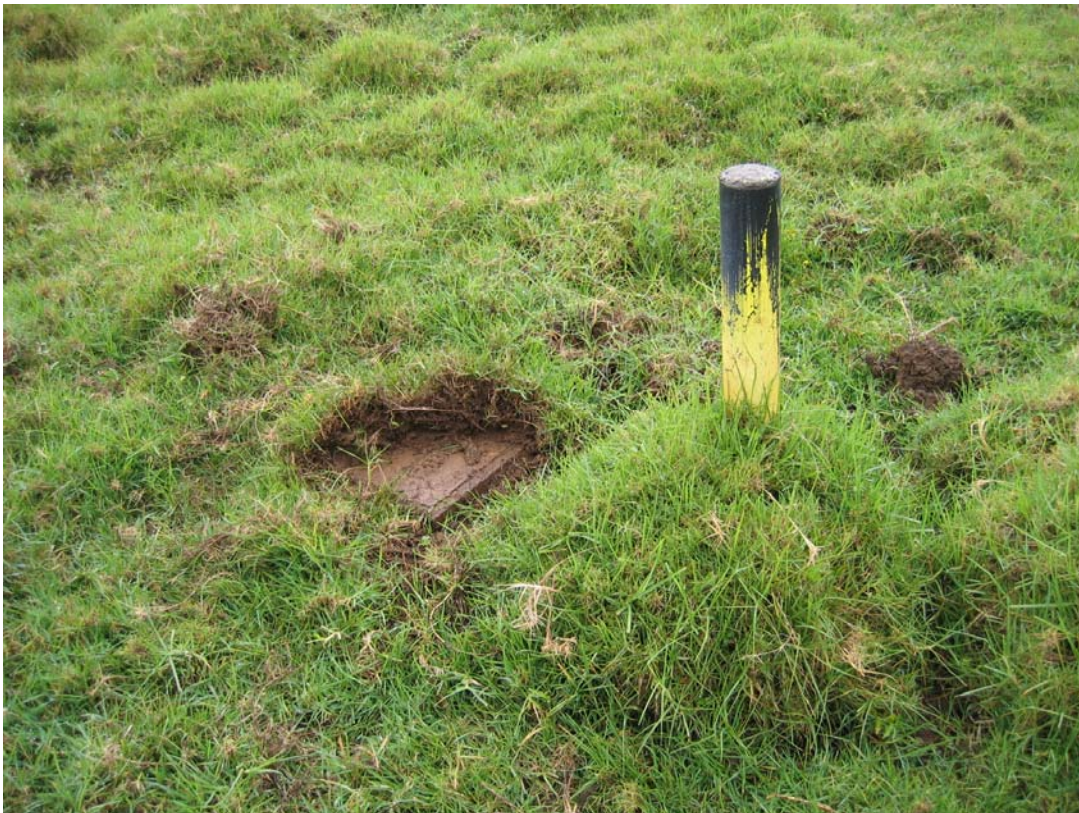
- a. The outlet works were not tested.
- b. The outlet works appeared to be in satisfactory condition, no corrective actions are required at this time.

**Photo 4 Outlet works valve box.**

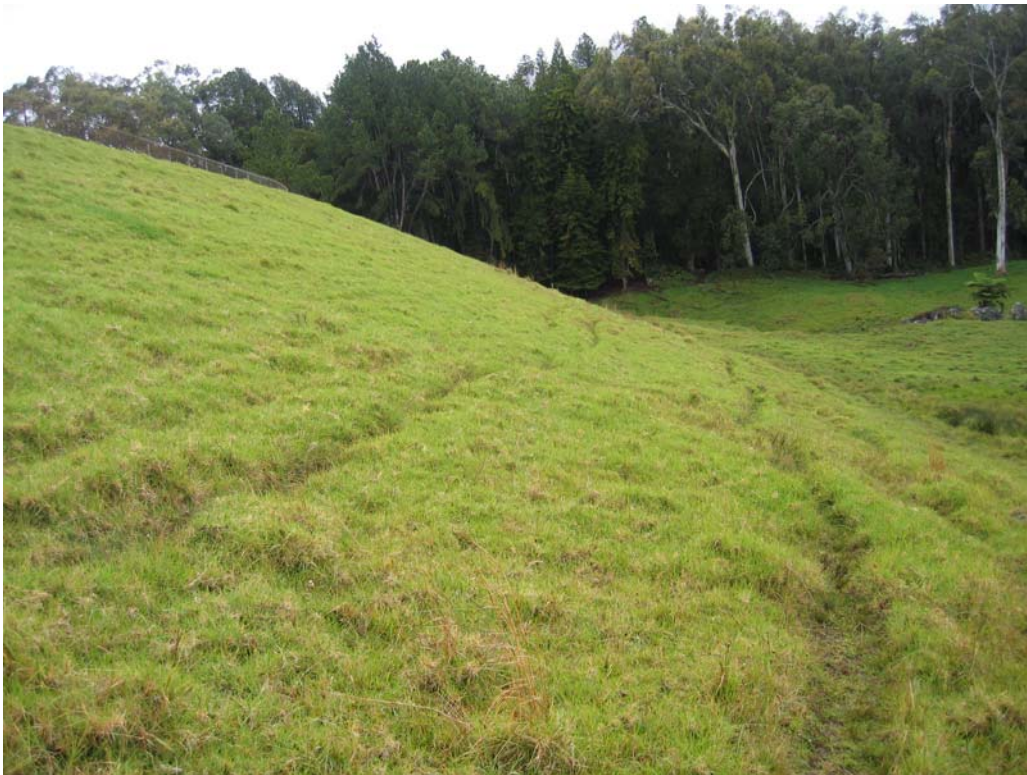
There was no slope protection observed on the downstream slope.

**Photo 5 Downstream slope.**

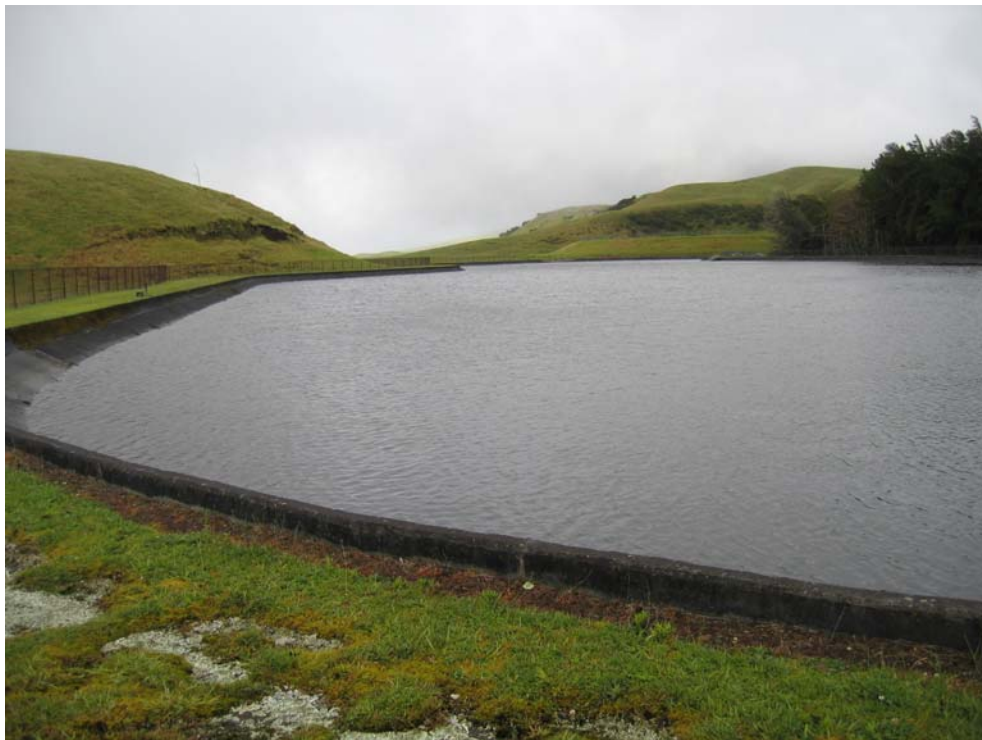
- a. The reservoir appeared to be in satisfactory condition, no corrective actions are required at this time.

**Photo 6 Reservoir overview.**

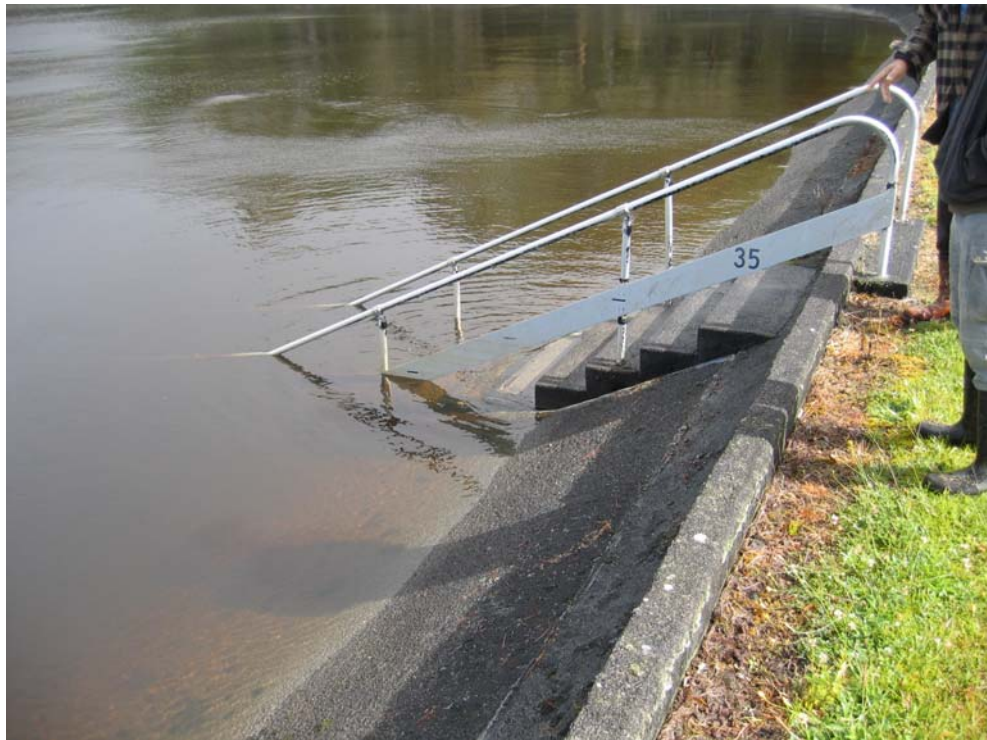
**Photo 7 Reservoir gage.**

Level during inspection 31.5 ft per gage (gage / other)  
Normal Operating Level/Range within range ft per gage (gage / other)  
Description: operated for water supply below spillway  
Typical Operation ☐ Spillway always flowing ☒ Kept within normal range ☐ Kept Empty ☐ Drained Daily ☐ Only filled by Storms  
☐ Other: \_\_\_\_\_  
Sinkhole in Res.: ☐ # Observed: \_\_\_\_\_ Size: \_\_\_\_\_ by \_\_\_\_\_ in. Deep ☒ Not Visible ☒ None Observed  
Description: reservoir full  
Staff Gage: Description: marked on access ladder.

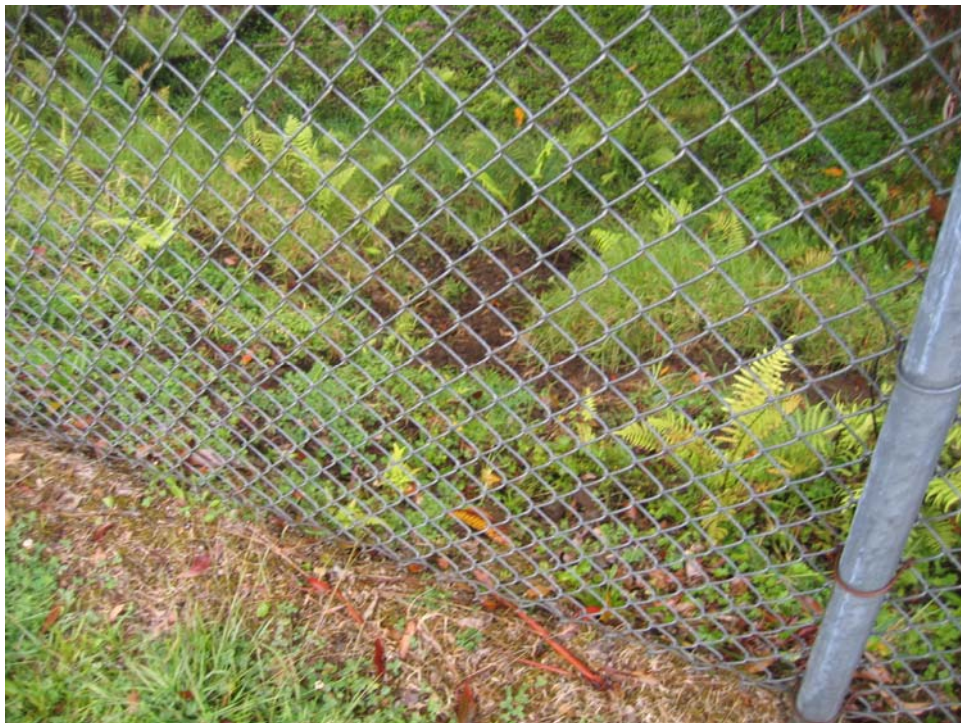
**Photo 8 Downstream slope erosion.**

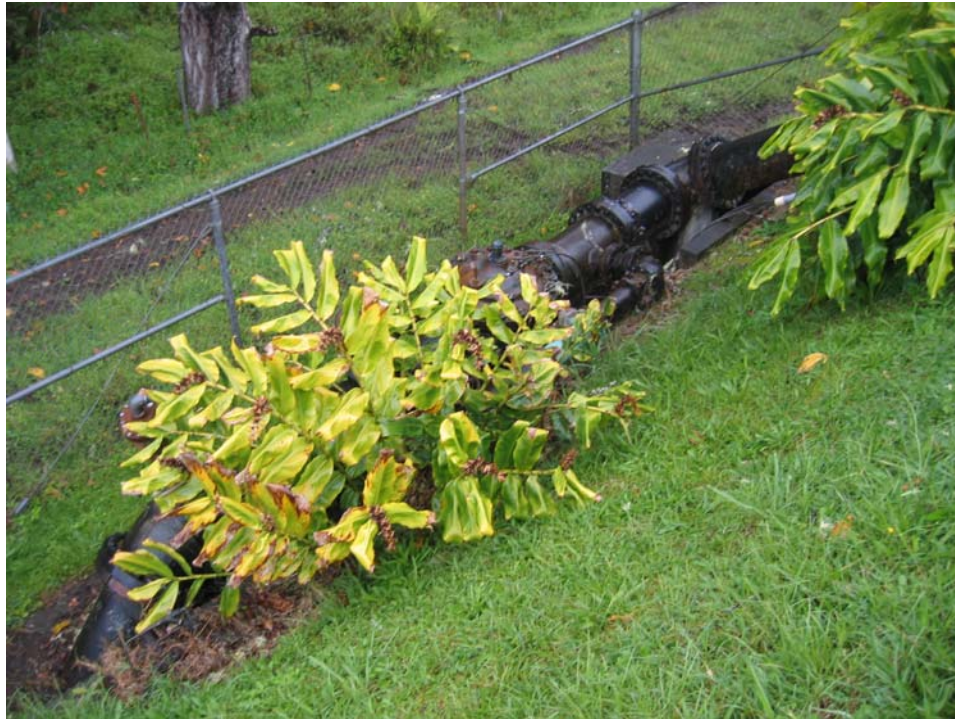
- a. The intake works were not tested.
- b. The intake works appeared to be in satisfactory condition, no corrective actions are required at this time.

**Photo 9 Intake piping and valves.**

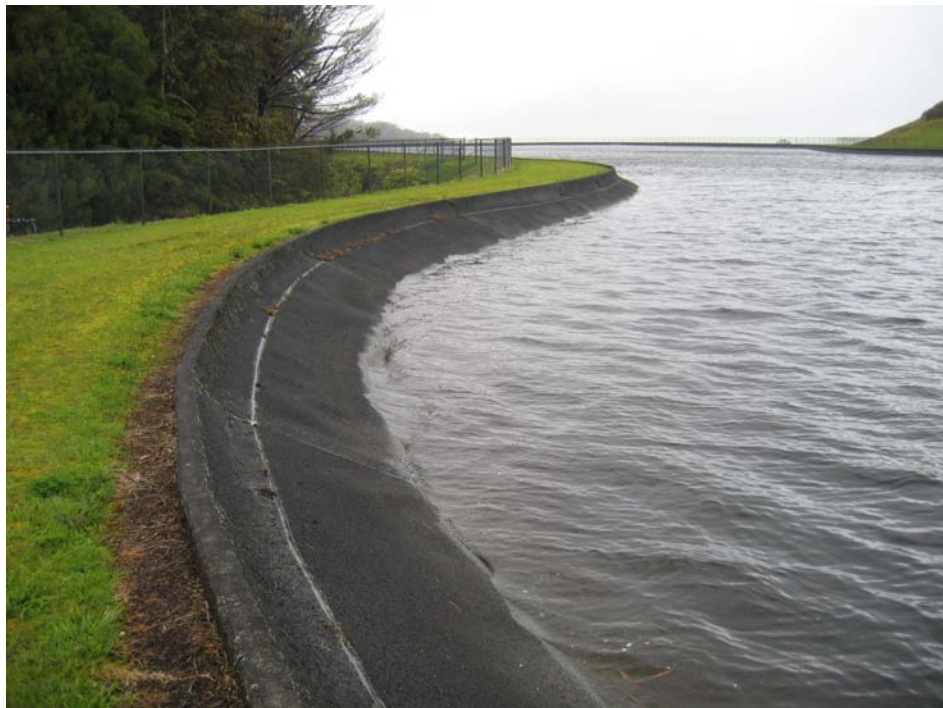
No erosions, cracks, or sinkholes were observed.

- a. The upstream slope appeared to be in satisfactory condition, no corrective actions are required at this time.

**Photo 10 Upstream slope.**

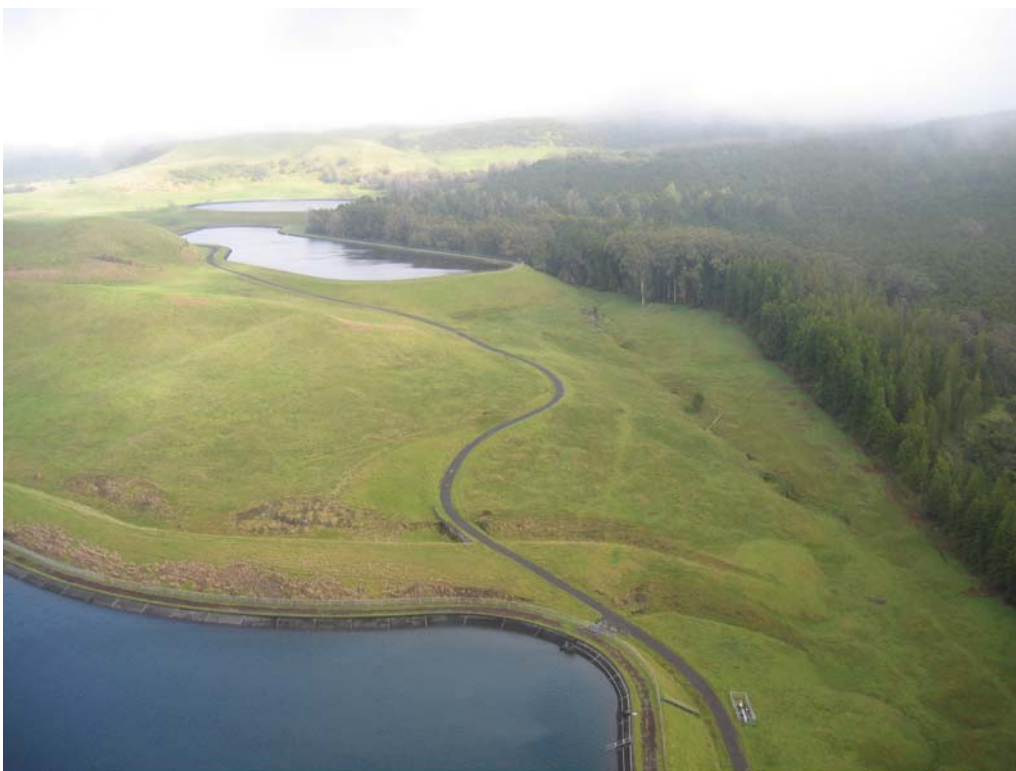
**Photo 11 Aerial overview of reservoir.**
